Numerical modeling of buckling failure in a mine slope

Carolina Helena Caldeira Silva

Milene Sabino Lana

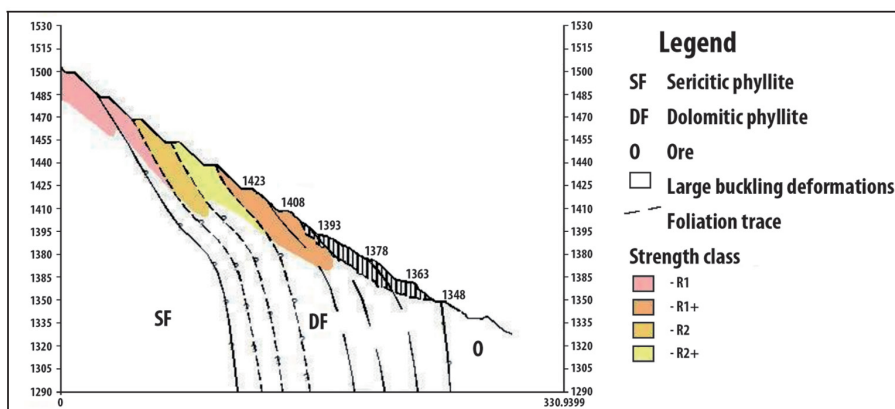
Figure 6
Proposed geologic model (BVP, 2007).

Buckling failure occurred in 2002, affecting many benches. A geological preliminary model to understand the phenomenon, proposed by a consulting company (BVP Engenharia, 2007), was used in the analyses. This model is represented by a typical geological section, see Figure 6. The foliation trace of the rock mass in Figure 6 shows the dip variability of this structure, due to folding, as described earlier and already illustrated in Figure 5.

Folding of the foliation, with the consequent verticalization of this structure creates the favorable kinematic conditions for buckling occurrence. Due to impact of the failure, it has been mandatory to maintain a hematite portion below the dolomitic phyllite to continue safe mining.

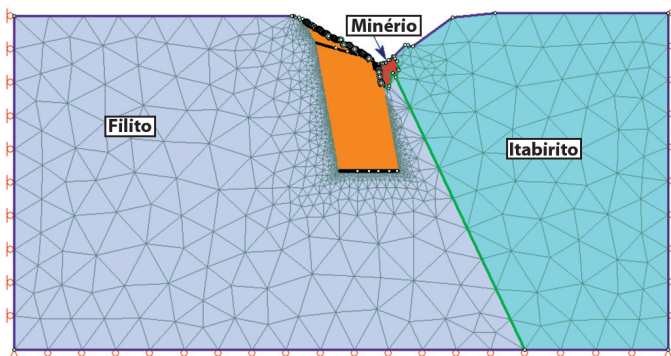
Figure 7

The simplified geological model used in the analyses is presented in Figure 7, with the finite element mesh generated in Phase2. Foliation discontinuities were explicitly inserted in the model, using joint elements, only in buckling occurrence region to decrease computational effort. A discontinuity spacing of 1m was used in the analysis to represent the observed spacing of layers affected by buckling in 2007. The discontinuities in the superior portion of the model have a dip value of 60°, which gradually increases to 80° in the inferior part of the model, to represent the folding of the foliation (Figure 6).

Boundary conditions in terms of displacements were taken for the analyses, see Figure 7. Displacements are fixed in x direction along lateral boundaries of the model and fixed in y direction along the bottom boundary.

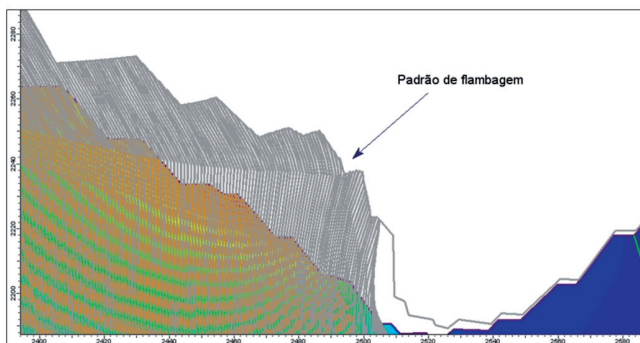
Figure 8
Discontinuity deformed boundaries, showing buckling failure.

in Figure 8, which shows the deformed boundaries of discontinuities. A scale factor to increase the size of deformed boundaries was used to allow the visualization of the model deformation mode. Buckling failure affected many

benches, so it could be interpreted as a global model failure; it is clear from Figure 8.

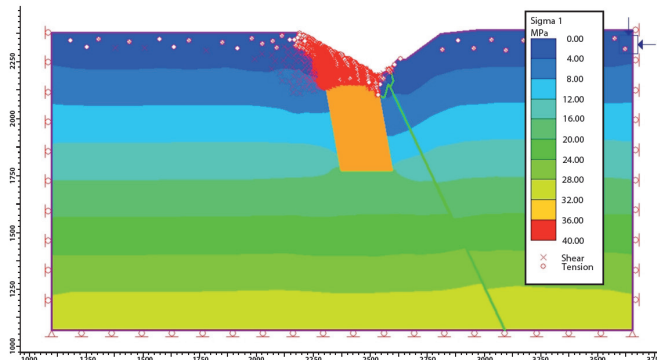
Yielded elements in the model are shown in Figure 9. Tension crack occurrences are observed along the slope top,

in the whole extension of the model, as described in BVP Engenharia report (2007). Yielded region is located mainly in the discontinuity region, showing their importance in slope failure mode.

Figure 9
Yielded elements in the model..
